MISCELLANEOUS PAPER S-72-5

# EVALUATION OF MO-MAT 158 AS LIGHT-DUTY LANDING MAT

February 1972

Conducted by **U. S. Army Engineer Waterways Experiment Station, Vicksburg, Mississippi**

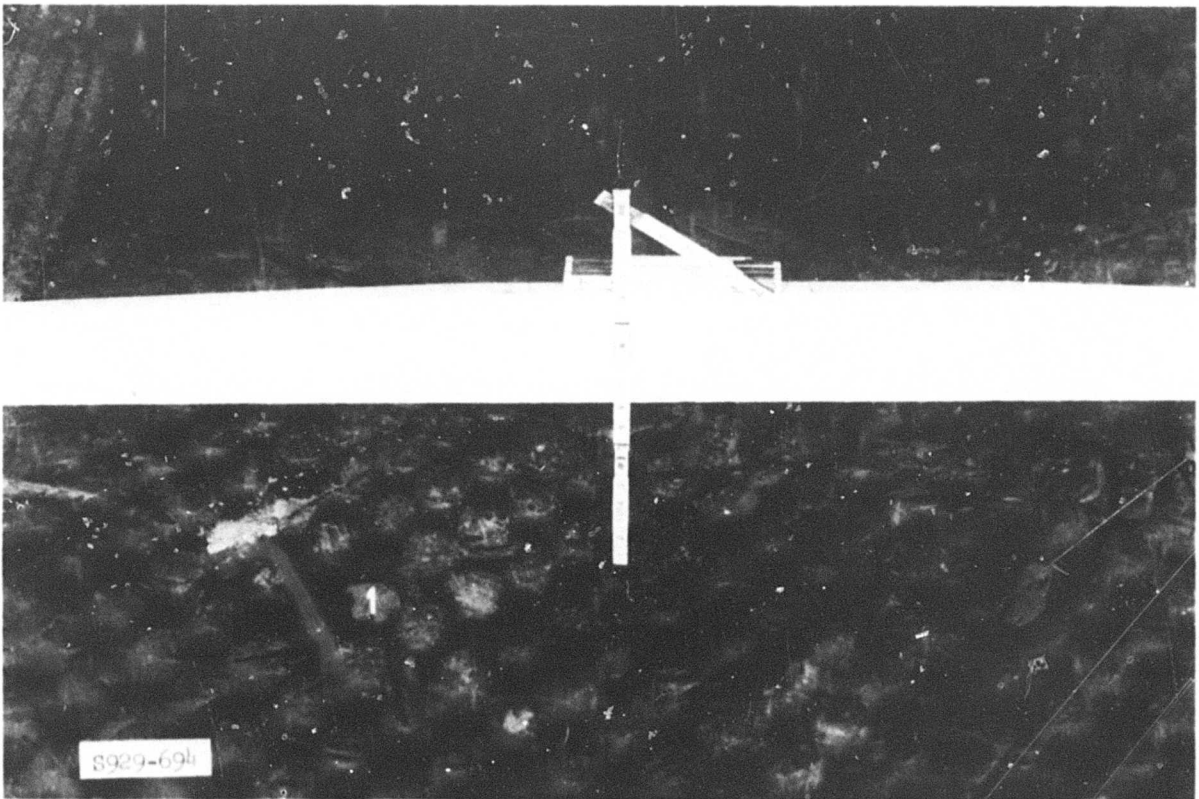
Photo 16. Measurement of 9-in. subgrade deformation on item 1 after completion of test 1

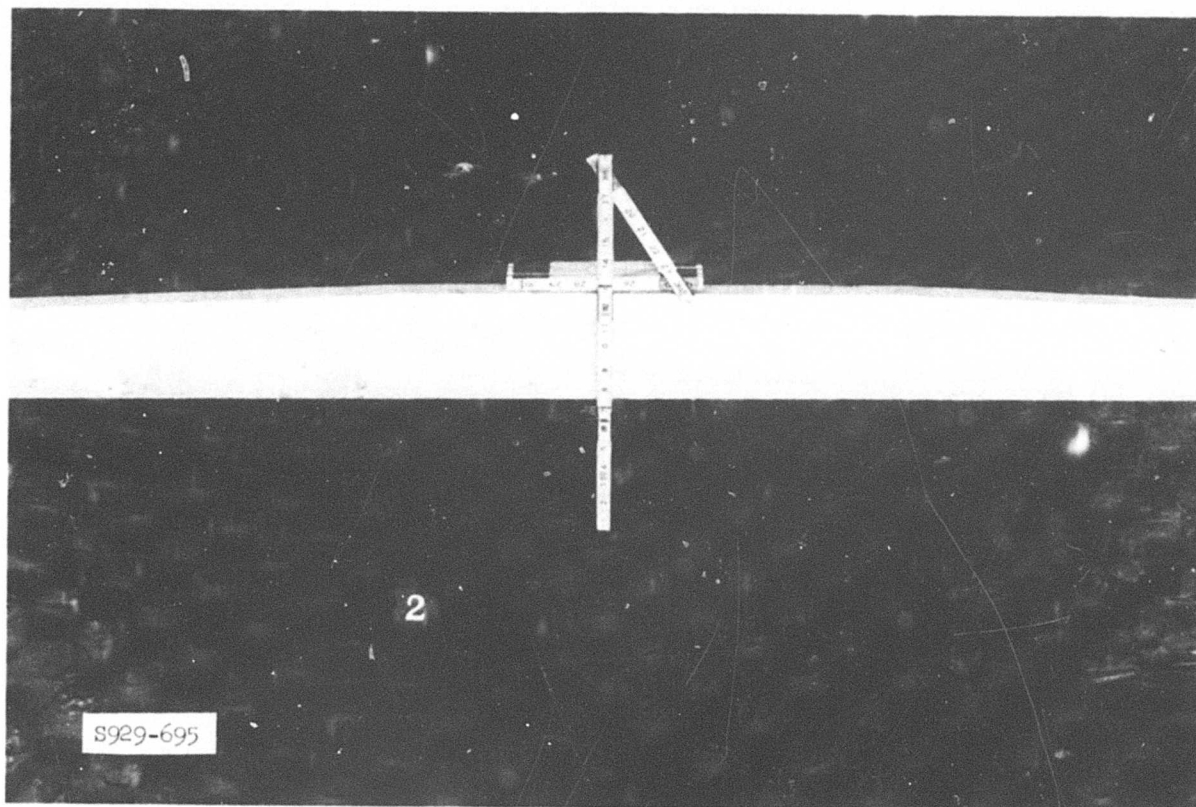
Photo 17. Measurement of 7-1/4-in. subgrade deformation on item 2 after completion of test 1

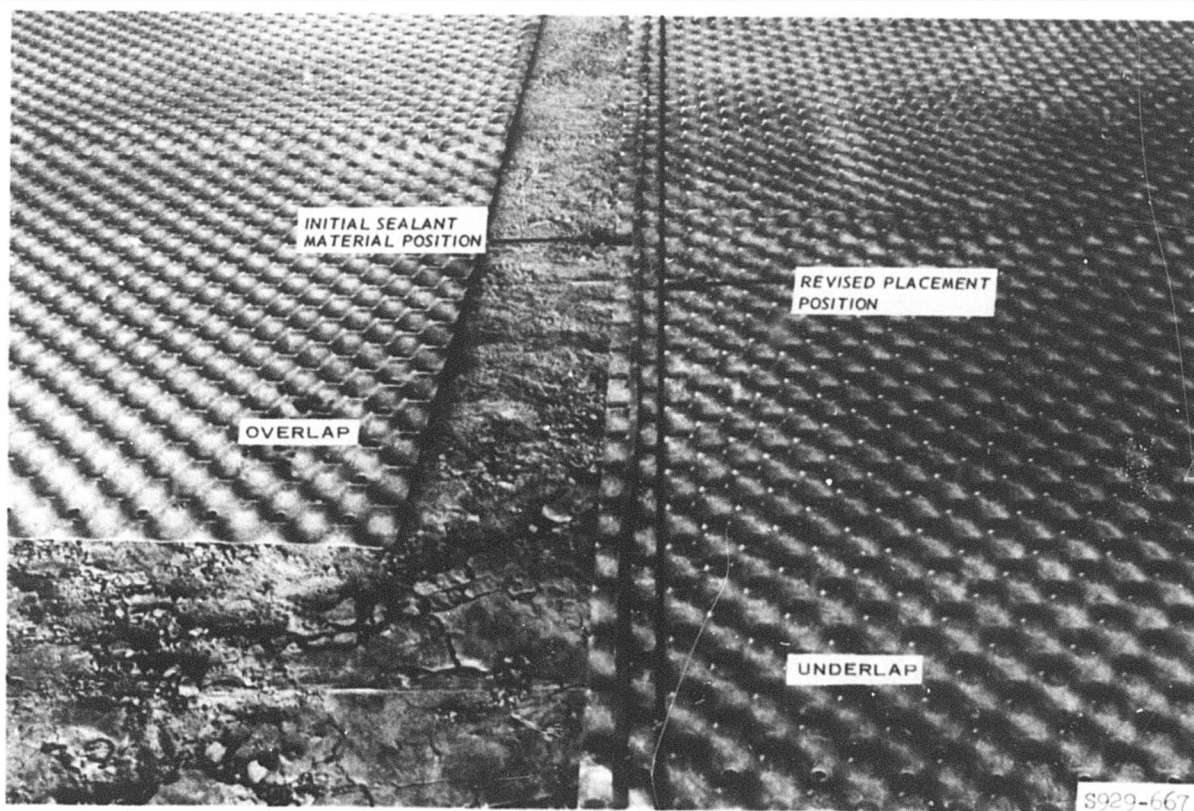
Photo 18. Placement of sealant material at joints

27. After all data had been taken from test 1, the test section was reprocessed to obtain a CBR of 10.0 (table 2) in order that the capabilities of the MO-MAT 158 could be further evaluated. Prior to rejoining the mat at sta 0+00 (plate 4), damaged longitudinal nut plates were replaced with new nut plates from sta 0+00 to 0+15. The manufacturer's initial recommended position of placement of sealant material to waterproof all joints is shown in photo 18. However, during test 1 this placement position allowed water to flow beneath overlap panels, seep through underlap panel bolt holes, and enter the subgrade. During repairs of the longitudinal joint from sta 0+00 to 0+15, the manufacturer recommended placement of sealant material on the opposite side of underlap panel bolt holes. The revised placement position is also shown in photo 18.

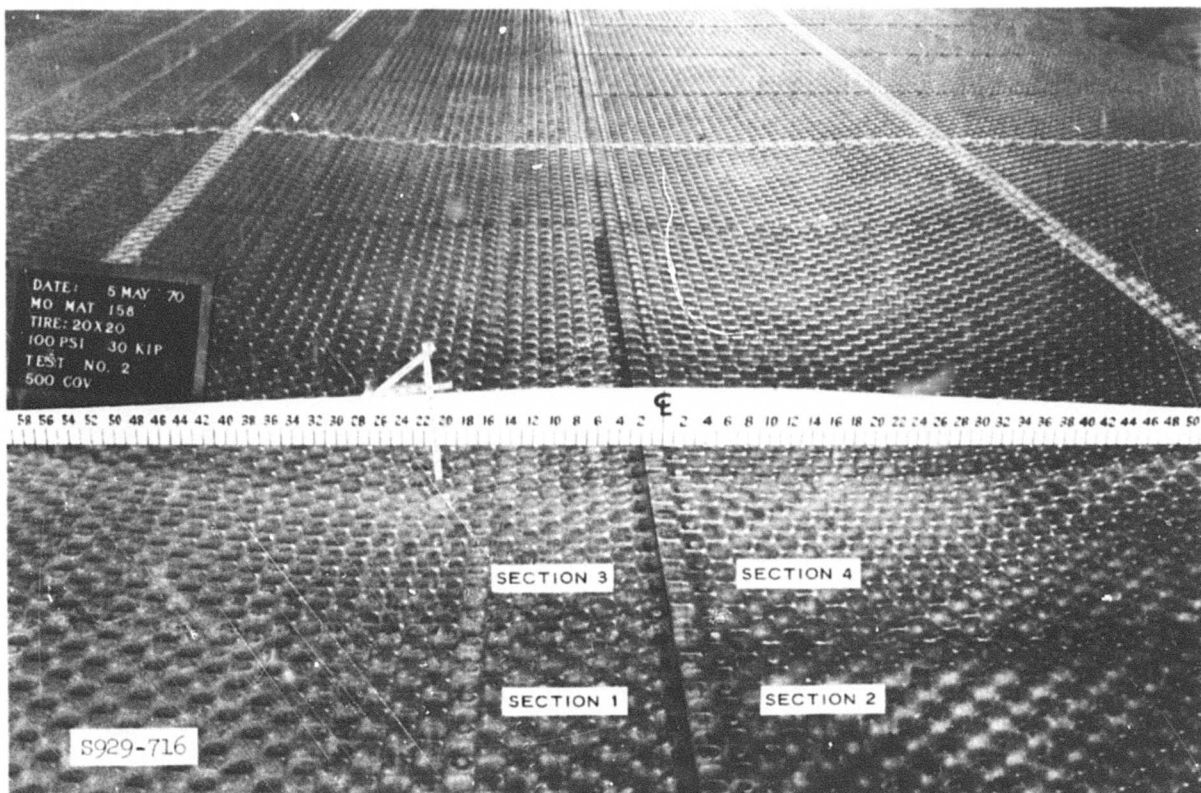
of traffic, a small crack was noticed that began 18 in. west of the longitudinal joint and terminated on the bonded joint between sections 2 and 4, 18 in. from the point of origin. The test section was considered failed after 500 coverages due to deformation of 3 in. across the traffic lane. A 3-1/2-in. deformation was measured on section 3, as shown in photo 20. Deformation measurements are presented in table 4. To bring the bridging mat in contact with the subgrade, the front wheels of a pickup truck were positioned transversely across the traffic lane, and deformations were measured with a 10-ft straightedge. Photo 21 shows a crack in the factory bonded joint between sections 2 and 4 as well as delaminations of material on section 4 after 500 coverages. The maximum change in static deflections beneath the tire from the beginning to 500 coverages of traffic was 0.3 in., which occurred at the center-line joint of sections 13-16 (plate 7). The maximum changes in both cross-section (plate 9) and profile (plate 10) measurements from the beginning to 500 coverages of traffic were 2.0 and 1.8 in., respectively.

Photo 20. View of 3-1/2-in. deformation across sections 3 and 4 after 500 coverages, test 2

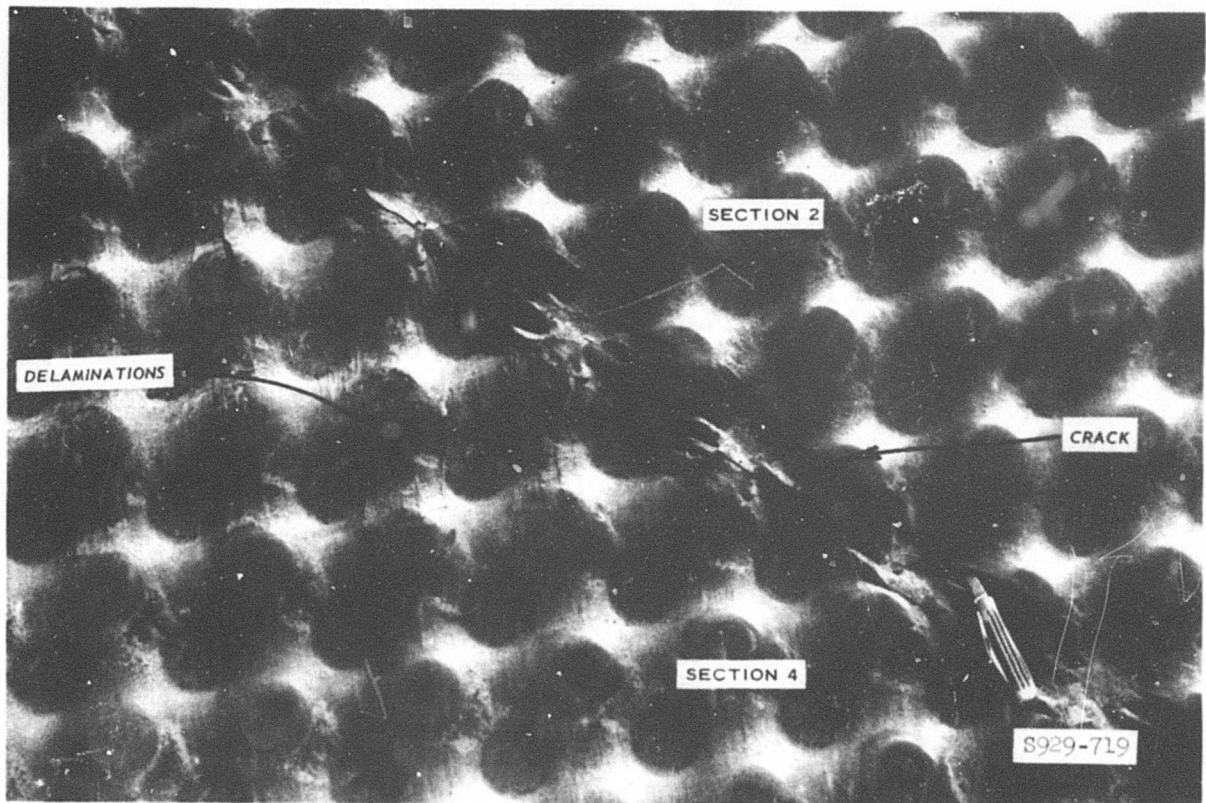
Photo 21. Crack in factory bonded joint between sections 2 and 4 and material delaminations after 500 coverages, test 2

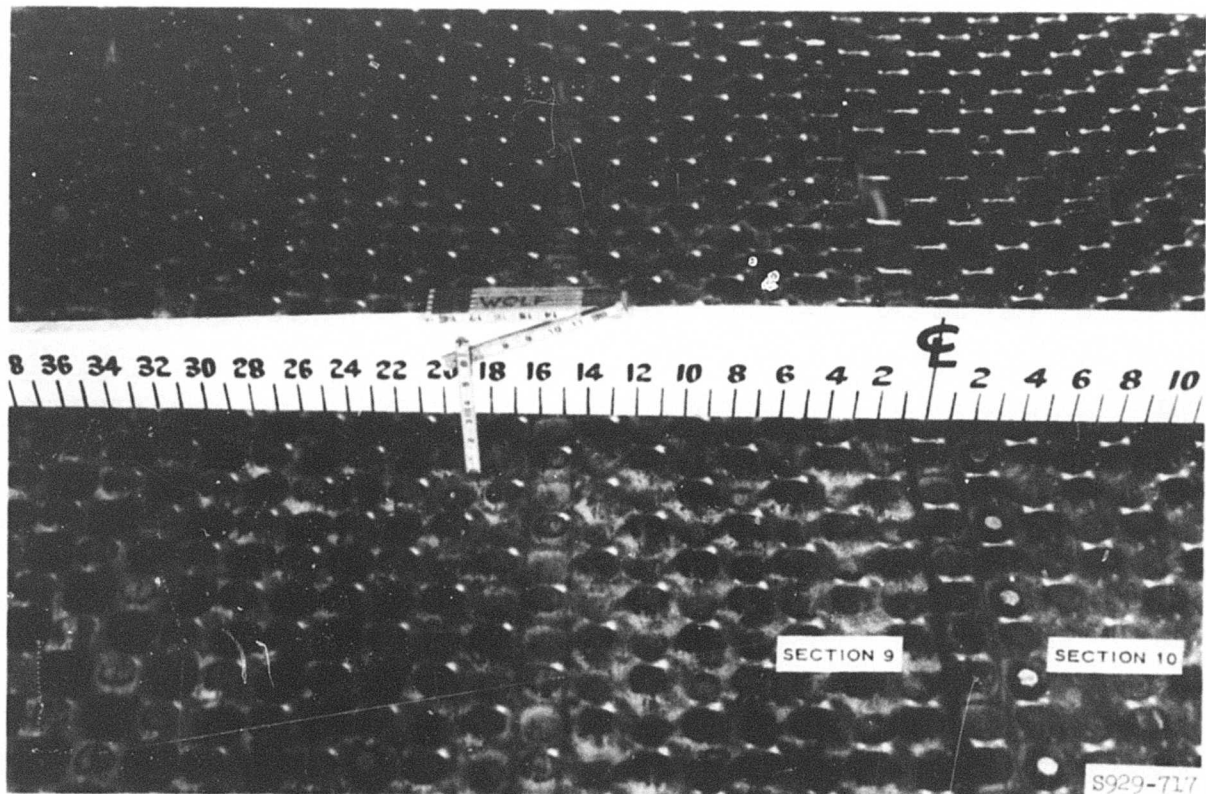
Photo 22. Measurement of 3-in. deformation across sections 9 and 10 after 600 coverages, test 2

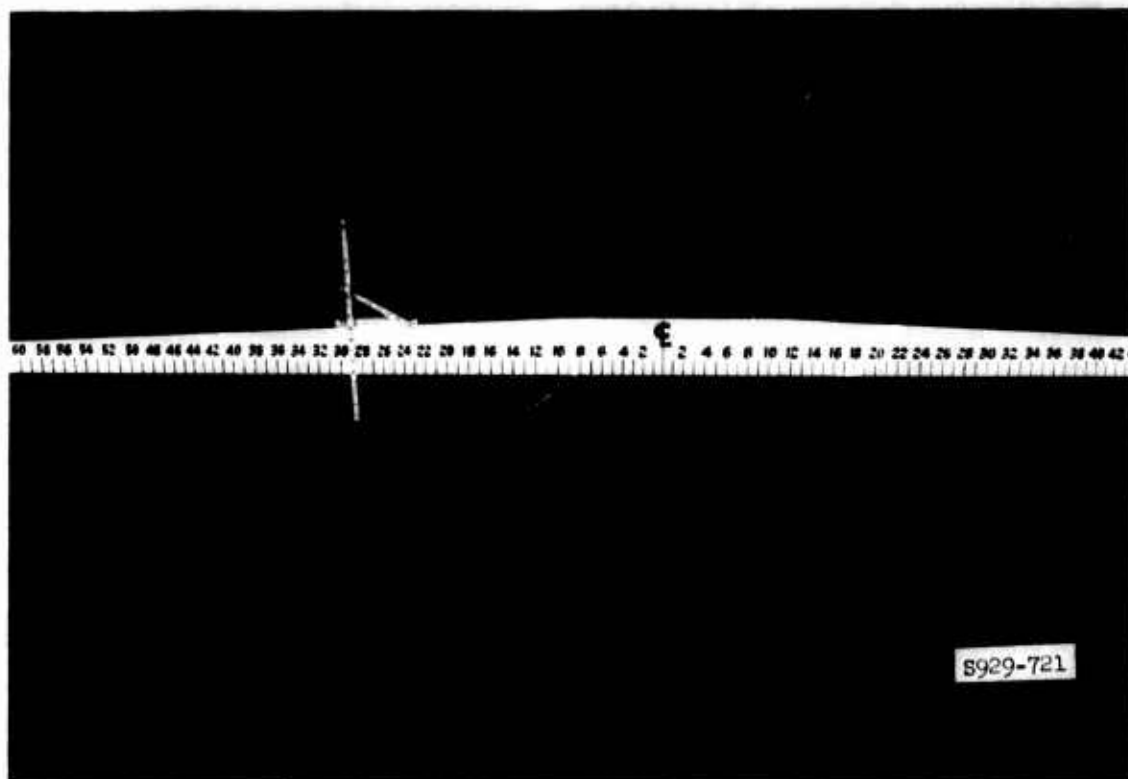
Photo 23. Subgrade deformation of  $4\frac{1}{4}$  in. beneath sections 3 and 4 after 500 coverages, test 2

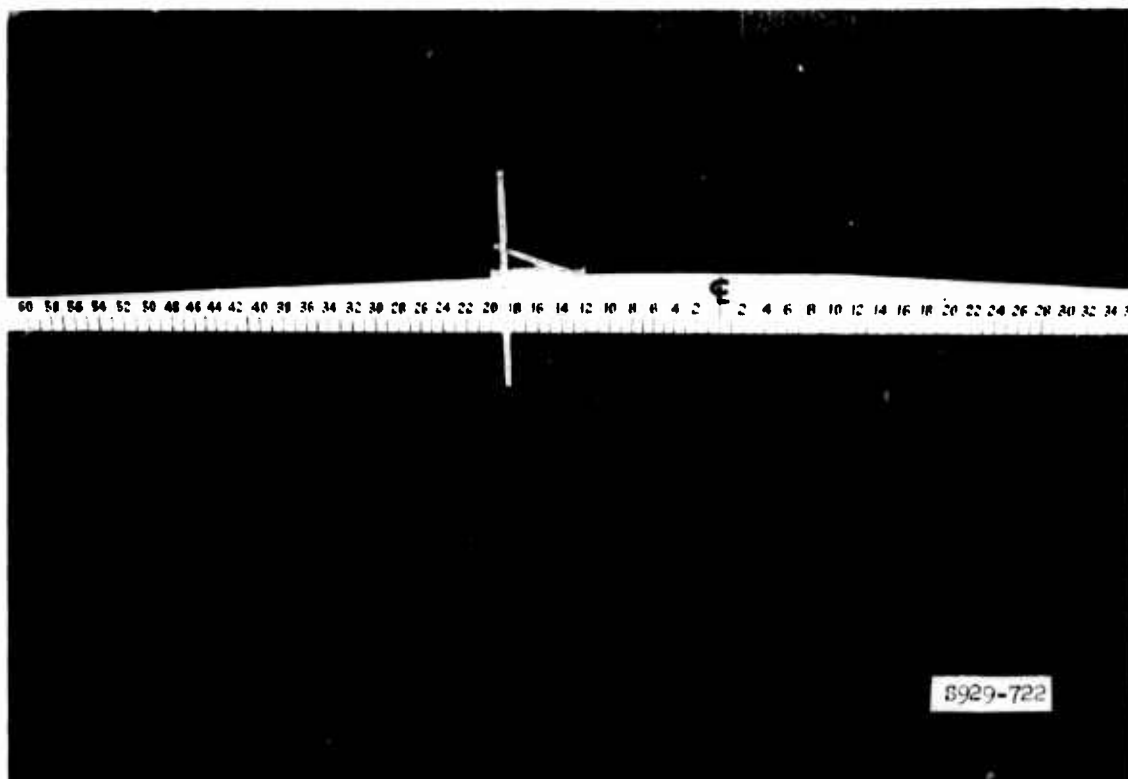
Photo 24. Subgrade deformation of  $4\frac{3}{4}$  in. beneath sections 11 and 12 after 600 coverages, test 2
